# KNOWLEDGE NOTE 1-5

## CLUSTER 1: Structural Measures

### Protecting Significant and Sensitive Facilities

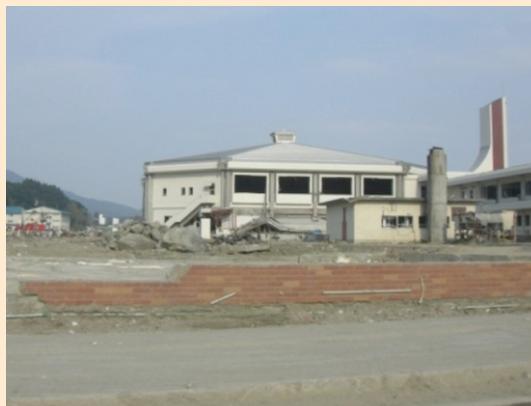
FIGURE 3: **The Rikuzentakata city gymnasium**

evacuate immediately after an earthquake, as distinct from evacuation centers) were inundated by tsunamis; and in Rikuzentakata City, one of the cities with the highest casualty rates, more than half the evacuation shelters were inundated. The city's gymnasium was designated as a primary evacuation shelter, and more than 80 people were there when the tsunami hit (figure 3). Only a few survived.

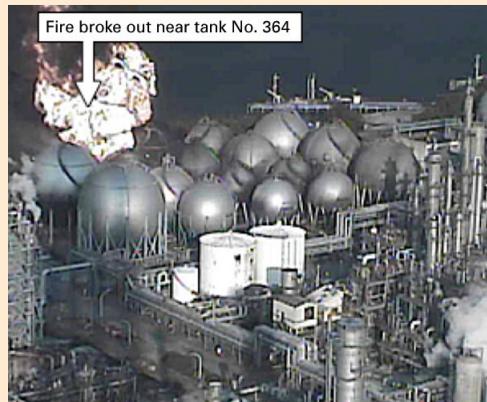
FIGURE 5: **Leaked LPG catches fire at a refinery**

**Industrial facilities.** Six out of nine oil refineries in the Tohoku and Kanto regions had to suspend operations; fire broke out at two of the nine facilities. At an oil refinery in Chiba, the structure holding one of the liquefied petroleum gas (LPG) tanks failed, and the tank collapsed, leading to LPG leakage. The leaked LPG caught fire and caused an explosion, spreading the fire from one tank to another (figure 5). Six people were injured and all 17 LPG tanks were damaged, along with pipelines and roads. The fire and debris from the explosions damaged the surrounding buildings and vehicles. Nearby residential areas also suffered as the blasts damaged windows, shutters, slate roofs, and more. The explosions at the oil refineries are believed to have been one of the factors that accounted for the fuel shortage immediately after the disaster, which disrupted people’s lives and hindered emergency recovery operations in the disaster-affected areas.

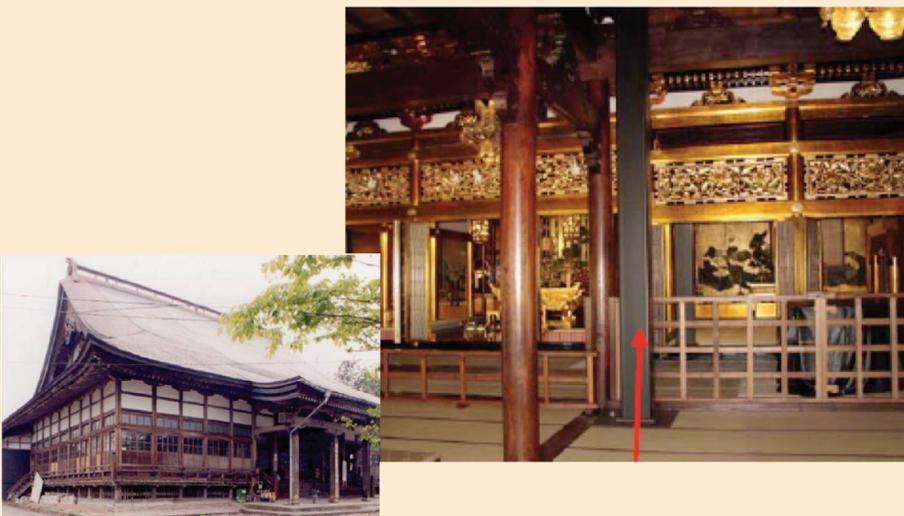
FIGURE 7: **Retrofitting Jokoji Temple**

Disasters that result in irreversible damage or losses of important cultural properties can have a severe negative effect on local businesses, such as those that depend on the tourism industry, and can also undermine people's pride in their communities. A culture-sensitive approach to restoration, in which original or local materials are used, is required to maintain the cultural value of historical buildings (figure 7). Retrofitting work should not be carried out in a way that destroys the historic value of the monument or building. If retrofitting cannot be carried out without compromising the structure's cultural value, the area should be closed to visitors rather than altered in a way that changes its character. Following the Great Hanshin-Awaji Earthquake in 1995, the Japanese government established guidelines for protecting cultural properties against earthquakes and began implementing seismic assessments and retrofitting structures associated with national treasures and important cultural properties.
